Guatemala Teaser

The Incident

On Saturday July 26, 2003 a hydrocarbon storage terminal in Guatemala suffered a lightning strike to one of their 95' diameter storage tanks, igniting gasoline that was temporarily stored within.

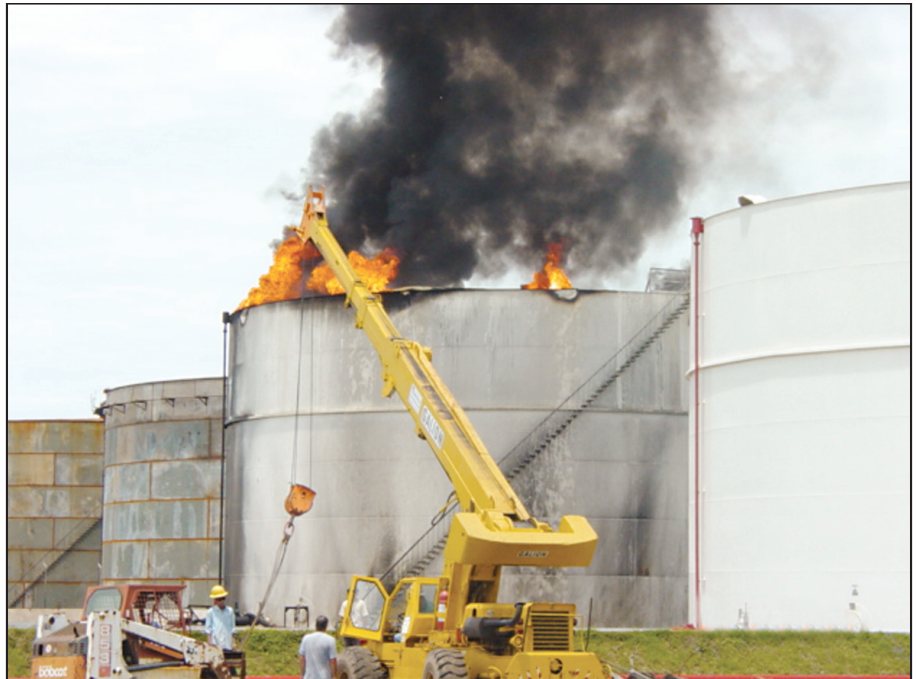
If the vapor space is in the flammable range at the time of ignition, but the outage is minimal or the vapor space is rich, fire at the vents is normally the result; the latter defines the incident in Guatemala. Although the full surface is not covered the vapor space inside the tank is too rich to burn. The flames occur once the vapor leans out with atmospheric air as it passes through the tank vents (see photo).

The vapor space within this cone roof tank demands a thorough knowledge of tank construction and fire dynamics — and of course ThunderStorm® ATC!

were present remain above the foam blanket. The vapors travel through the vents, (in this case 10 ea. / 18 inch.) mix with the air and burn. The volume of burning vapor is miniscule; the 4-feet of outage in the Guatemalan tank fire was roughly 42,000 cubic feet. Based on the vapor pressure of the product and the 10 - 18-inch vents, the vapor duration could easily last for over 12 hours. The foam blanket will break down long before the vapor is depleted, and the process starts all over again, depleting the facility's foam supply.
